Manhole Inspection Summary

Manhole # S01EE2021MH

Location Address: **6306 Benhurst Rd**

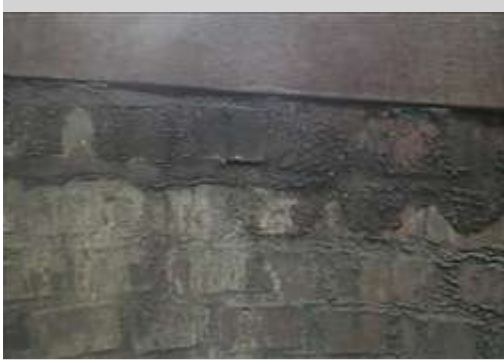
Defect

Infiltration: ☐ None ☒ **Joint** ☐ Cracks ☒ **Mortar** ☐ Roots ☐ Wall

infiltration at frame connection

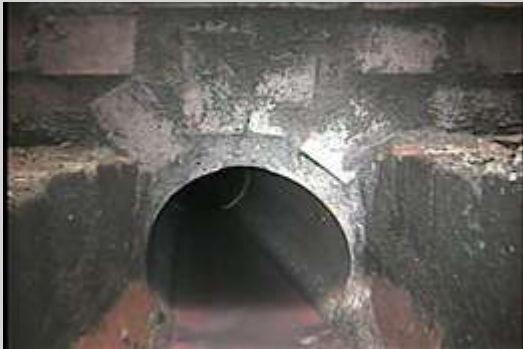
8 in. Circular Gravity Sewer Pipe Out @ 12 O'Clock

Deposits: ☐ None ☐ Mud ☐ Sludge ☒ **Debris** ☐ Grease

Silt Depth: **0.125** (in.) Deposits Extent: **Medium**

Infiltration: **None** Pipe Seal Cond: **Sound**

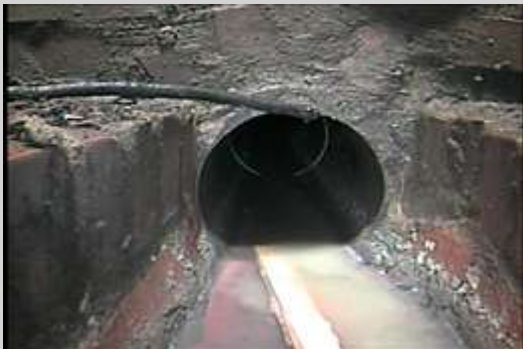
8 in. Circular Gravity Sewer Pipe In @ 6 O'Clock

Deposits: ☐ None ☐ Mud ☐ Sludge ☒ **Debris** ☐ Grease

Silt Depth: **0.125** (in.) Deposits Extent: **Medium**

Infiltration: **None** Pipe Seal Cond: **Sound**
